A METALLOGRAPHIC EVALUATION OF SOME COATED COLUMBIUM ALLOYS.

V. Griffiths

Montana College of Mineral Science & Technology

Technical Report on NASA Contract

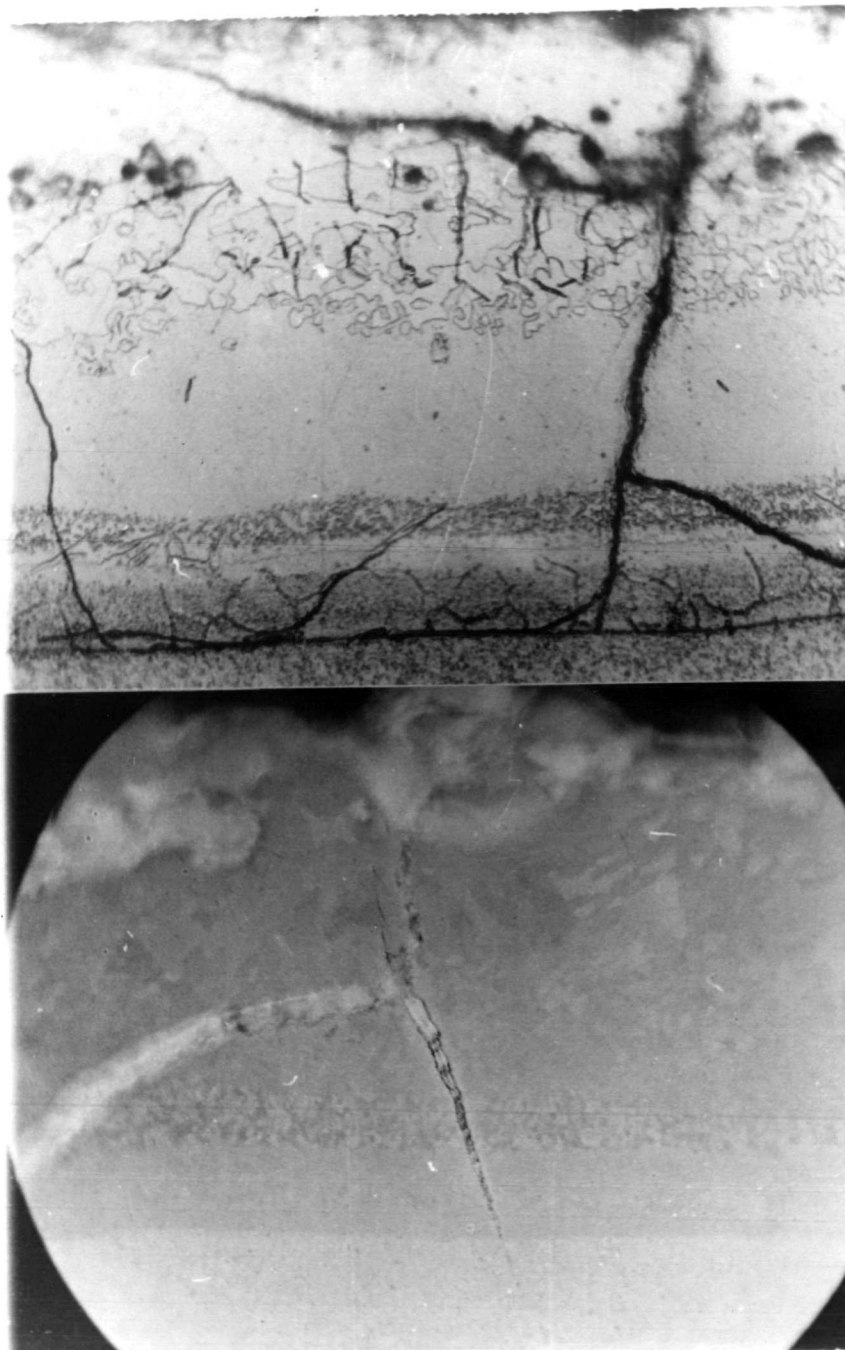
Representative optical metallography sections of R512E, and VH109, both as received, are shown respectively in Plates 1 and 2. R512E is shown etched in Plate 1A and in Plate 1B it is shown through deeply crossed polarizer/analyzer and essentially unetched. These do not show the same field but nonetheless the difference between the two is quite striking. The polarized light micrograph 1B, reveals the grain structure of the coating and reveals generally a very fine grain size next to the substrate (bottom) and a large grain size near the outer surface (top). Different layers are visible but fine cracks are not readily discerned. The etched sample shows cracks readily and also shows different composition layers and apparent second phase. Cracks in the coating do not follow the grain boundaries; they usually do not penetrate the substrate but 1B is an illustration of a crack which has penetrated the substrate. The cracks are usually wider at the outer surface than at the substrate; this and other characteristics generally suggest that they were induced by thermal (tensile) stresses set-up during cooling from the formation temperature. Cracks are also seen in optical and SEM micrographs of the surface (see for example Plate 4 & 5).

Plate 1A) R512E coating deeply etched bright field substrate at bottom. Note cracks and evidence of differing composition across coating. 425X B) R512E, etched, crossed polarizer/ analyzer. Grains structure of coating is visible. 425X

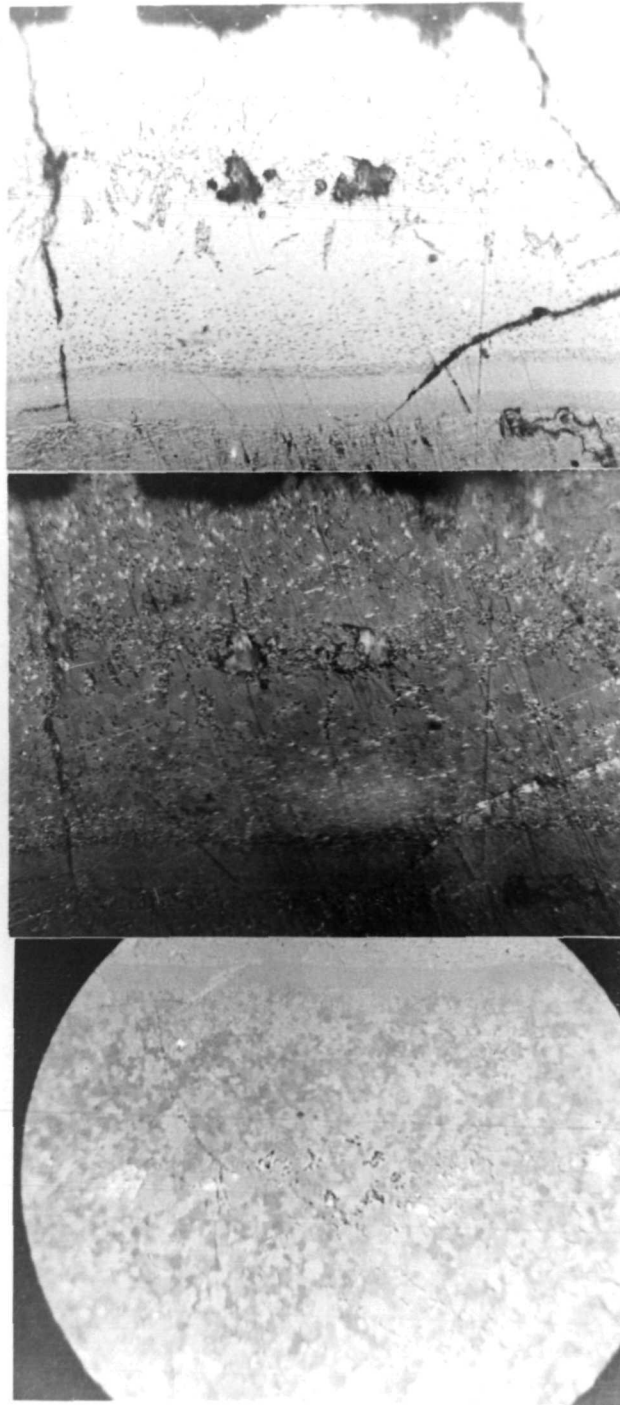
Plate 2 shows VH109; 2A and 2B are of the same area, etched, in bright field and in polarized light. The etchant has eaten away second phase leaving small pits which appear as very bright areas under polarized light. 2C is another field under polarized light, this sample etched very lightly relative to 2A.

Plate 2 A & B (top & middle) show same area. VH109, bright field & polarized light respectively. C shows another area, polarized light. All at 425X.

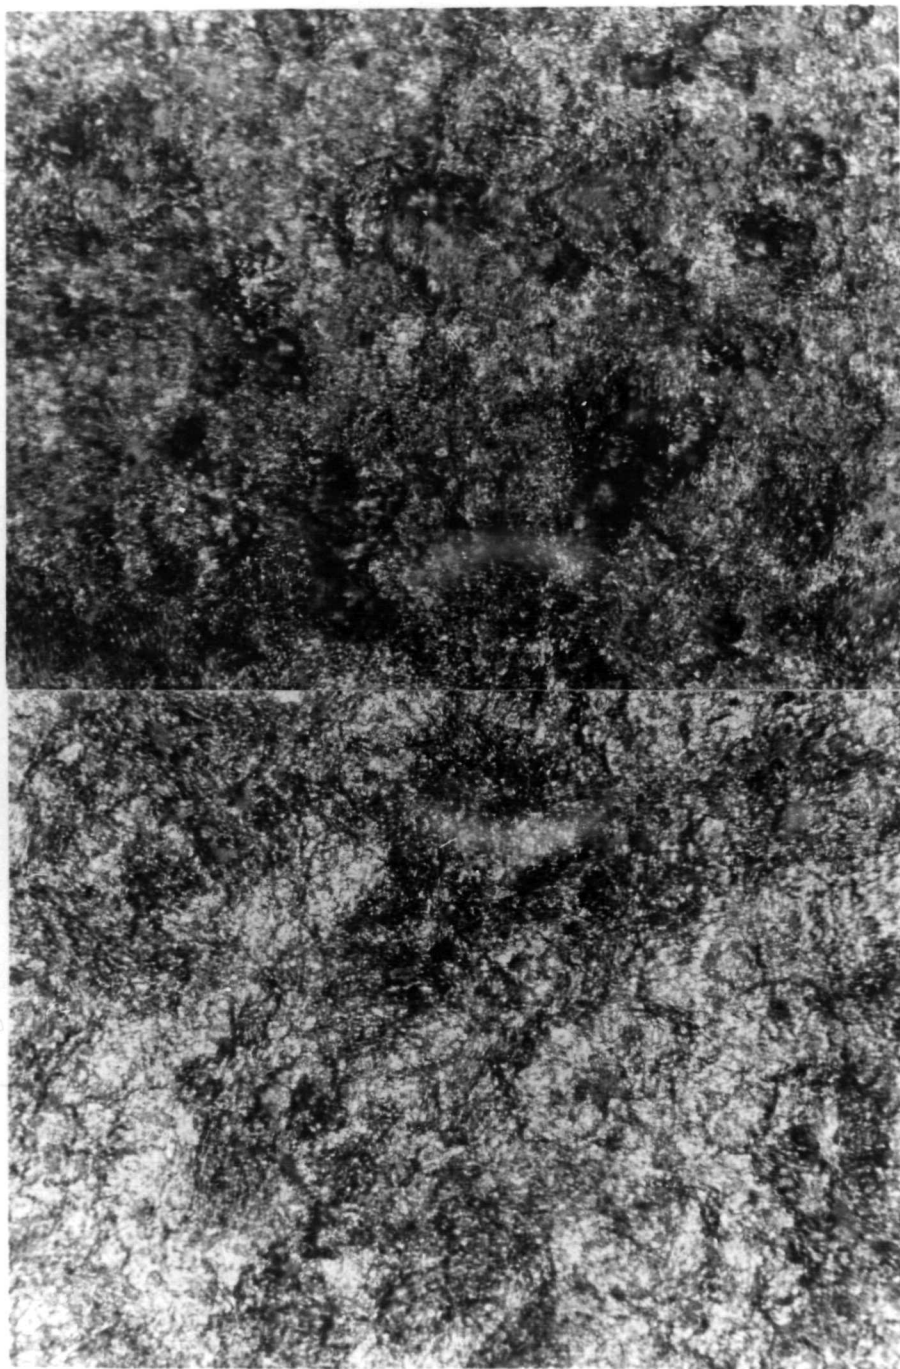
Plate 3 shows dark field micrographs of R512E and VH109. Although both 3A and 3B have surface cracks they are not readily visible in these photomicrographs and generally these plates illustrate the desirability of higher magnifications such as are possible via SEM.

Plate 3 A) Bottom, dark field optical micrograph of outer surface of R512E at 90x. B) Top, same but VH109. Both show surface cracks.

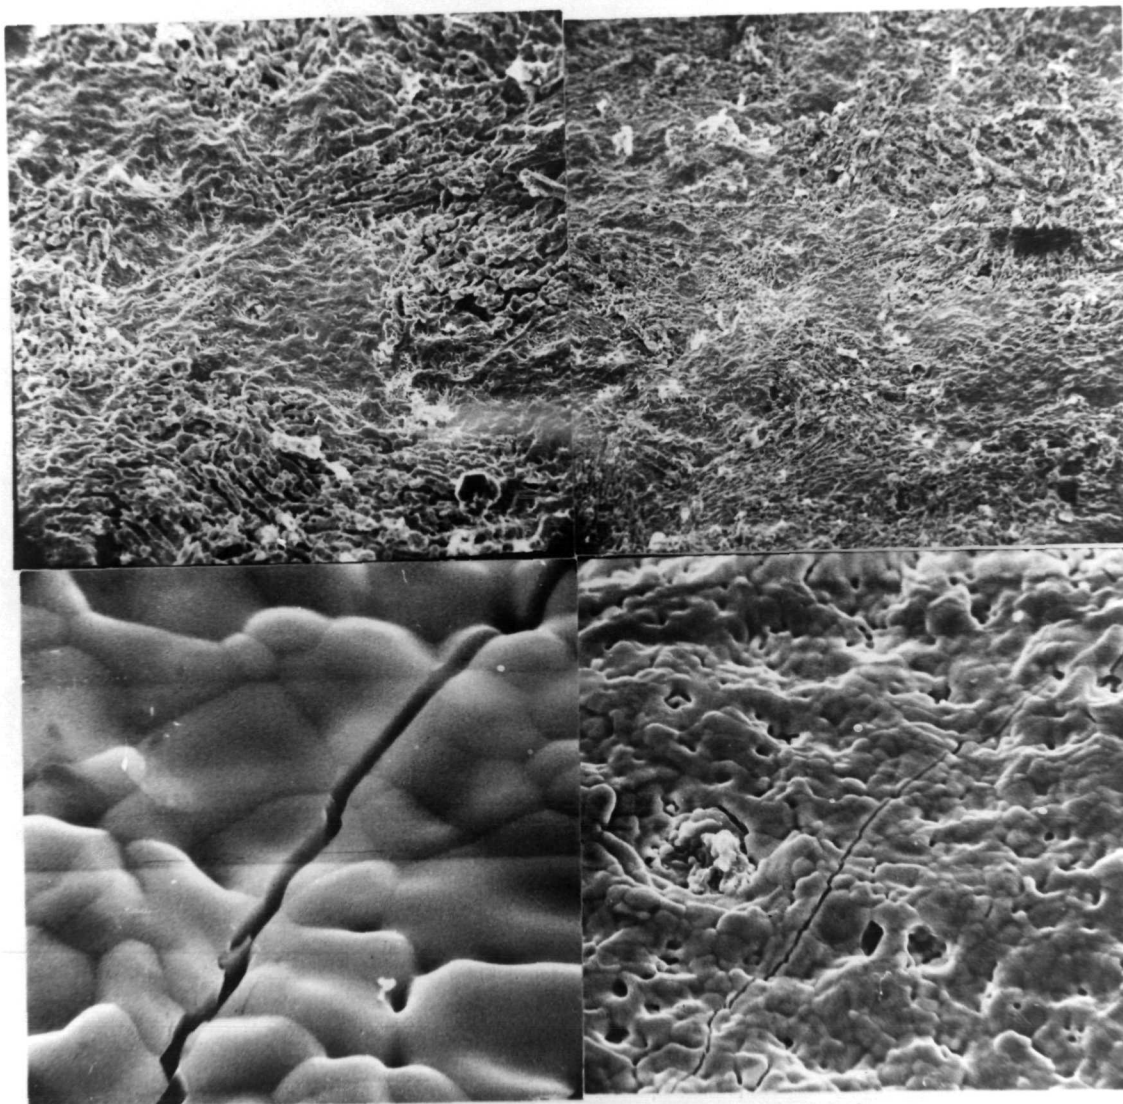
Plate 4 shows SEM micrographs of as received R512E and Plate 5 shows SEM micrographs of as received VH109. These micrographs illustrate the superior rendition of surface detail that the SEM makes possible. Both coatings are seen to be cracked, the variation in texture of the surface from point to point is clearly visible particularly in Plate 4 of R512E at 500X. The cause of this texture is unknown. Plate 4D, at 10,000X shows features suggesting grain boundaries. The diameter of these "grains" corresponds very roughly with the grain size one might estimate from polished cross sections. The crack visible in Plate 4 crosses these grains more or less randomly suggesting a crack which opened up under a tensile stress.

Plate 4 SEM micrographs of R512E. All are of same area. Upper right 200x, upper left 500x, lower right 2000x, lower left 10,000x. Note surface cracks and varying texture in 200x and 500x photos. Compare with Plate 3A. Features in 10,000x photo are thought to represent grains.

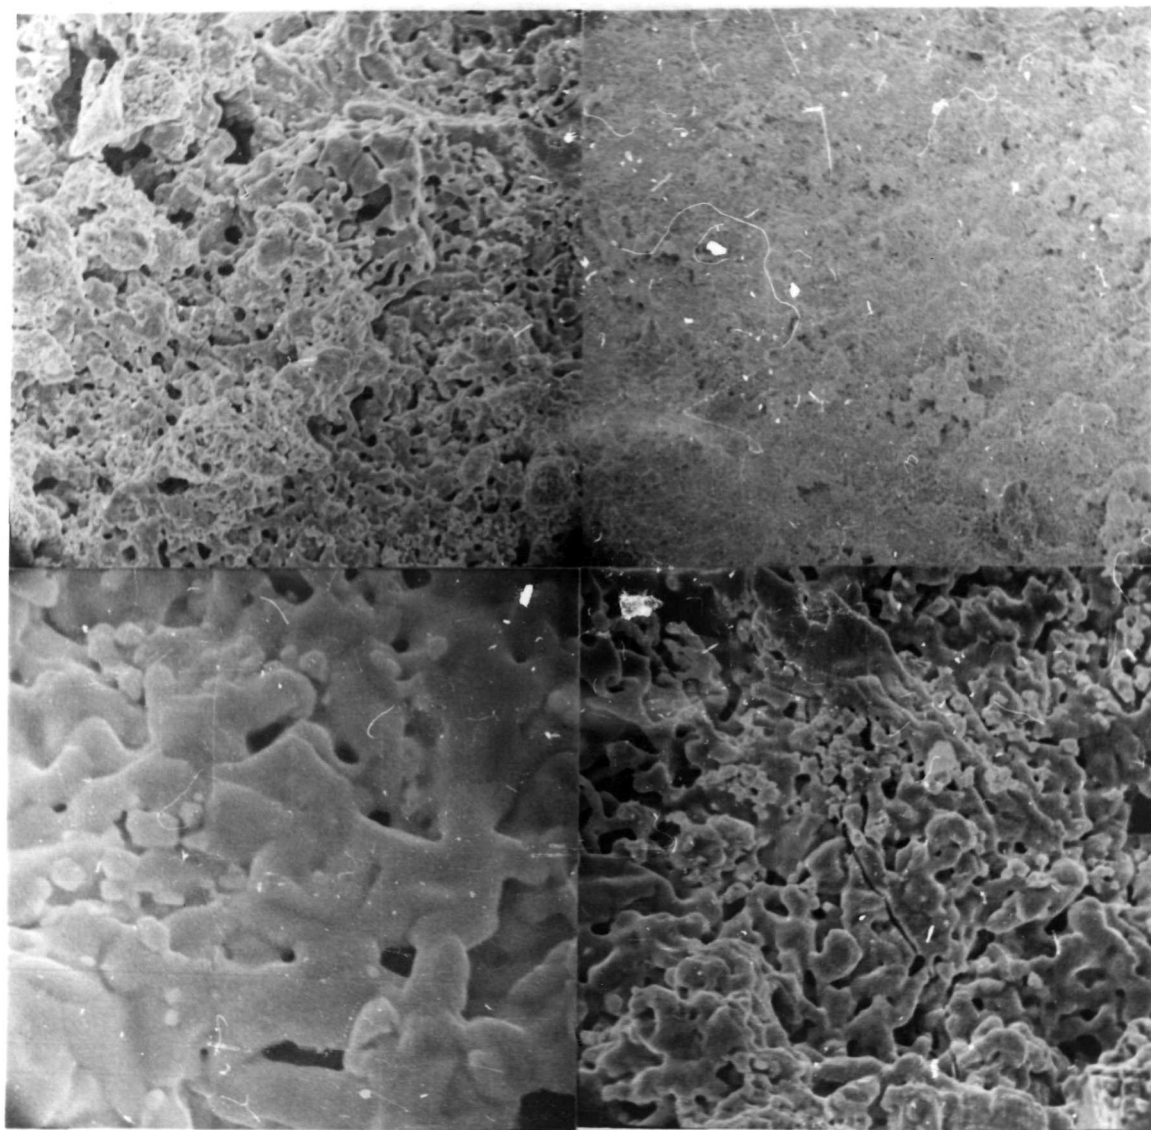
The surface structure of VH109 shown in Plate 5 is seen to be different in detail and is presumably due to the different composition and method of application. Plates 6, 7 and 8 show optical metallography sections of coatings after cycling to elevated temperature. Plates 6 and 7 show R512E. Plate 6 is after furnace cycling, 5 times, in air to 2400^OF and Plate 7 is sample R1 (Ecord), which has been arc-jet tested to a similar temperature. Plate 8 shows VH109 after furnace cycling. The polished sections show little change except that a columnar morphology may be deleterious if it offers easy crack paths through the coating. The reason for the development of the columnar structure is unknown.

Plate 5 SEM micrographs of VH109. All are of same area. Upper right 200x, upper left 1000x, lower right 2000x, lower left 5000x. Surface cracks are also present here.

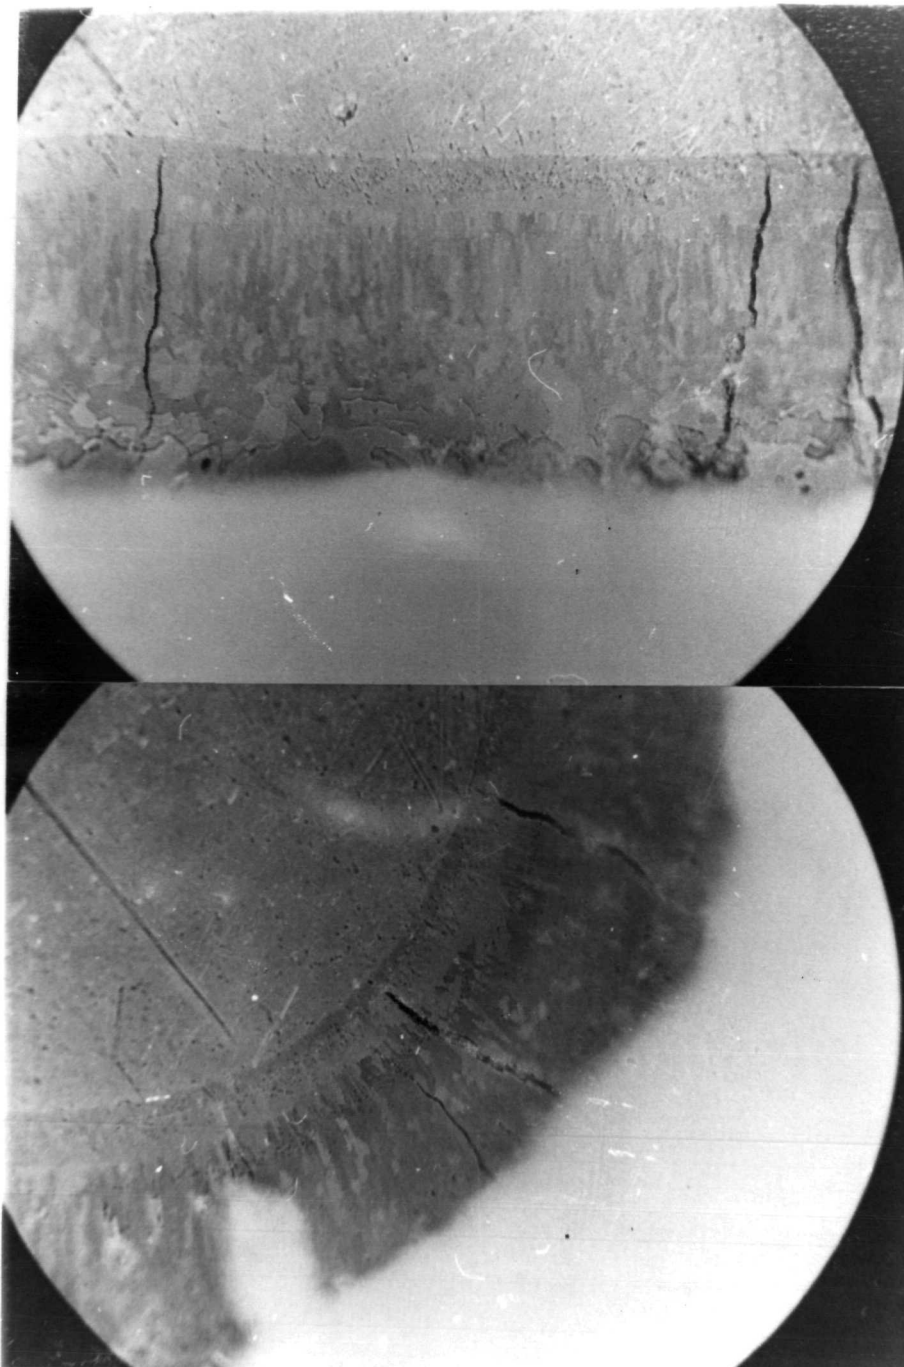
Plate 6 R512E after furnace cycling, 5 times, in air, to 2400°F. The coating has developed a columnar morphology but no other changes are discernible. Polarized light, 425x.

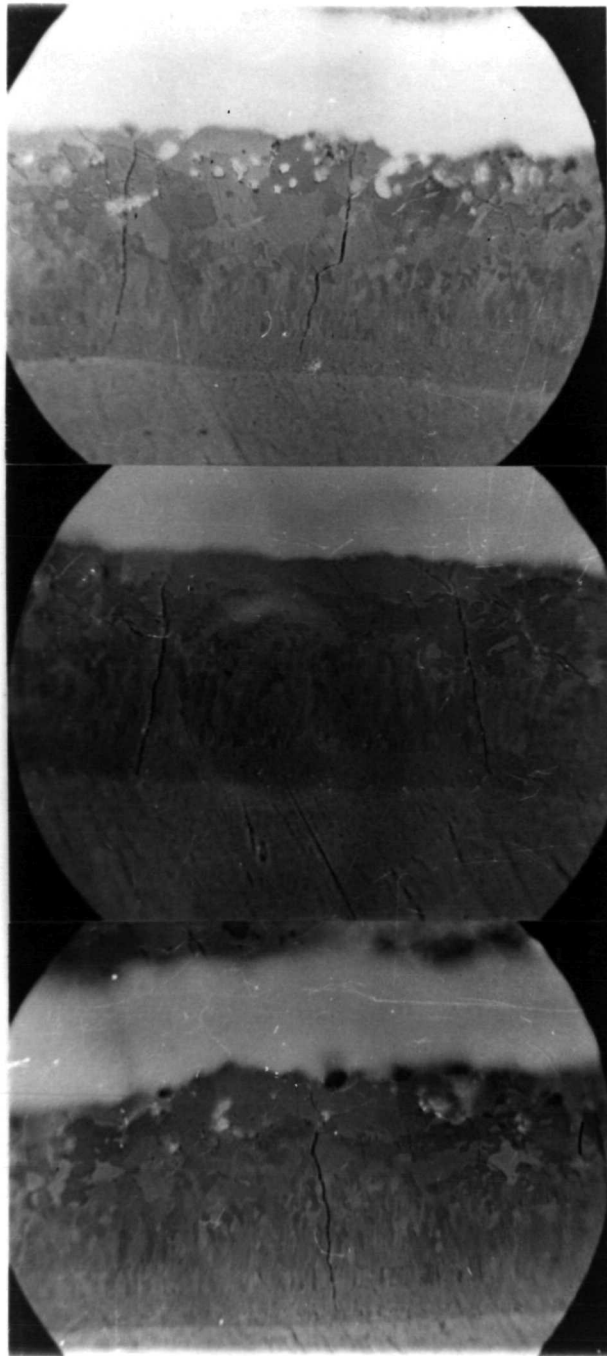
Plate 7 R512E after 5 cycles of arc-jet testing to nominal 2400°F. Columnar coating morphology. Similar to Plate 6. Polarized light, 425x.

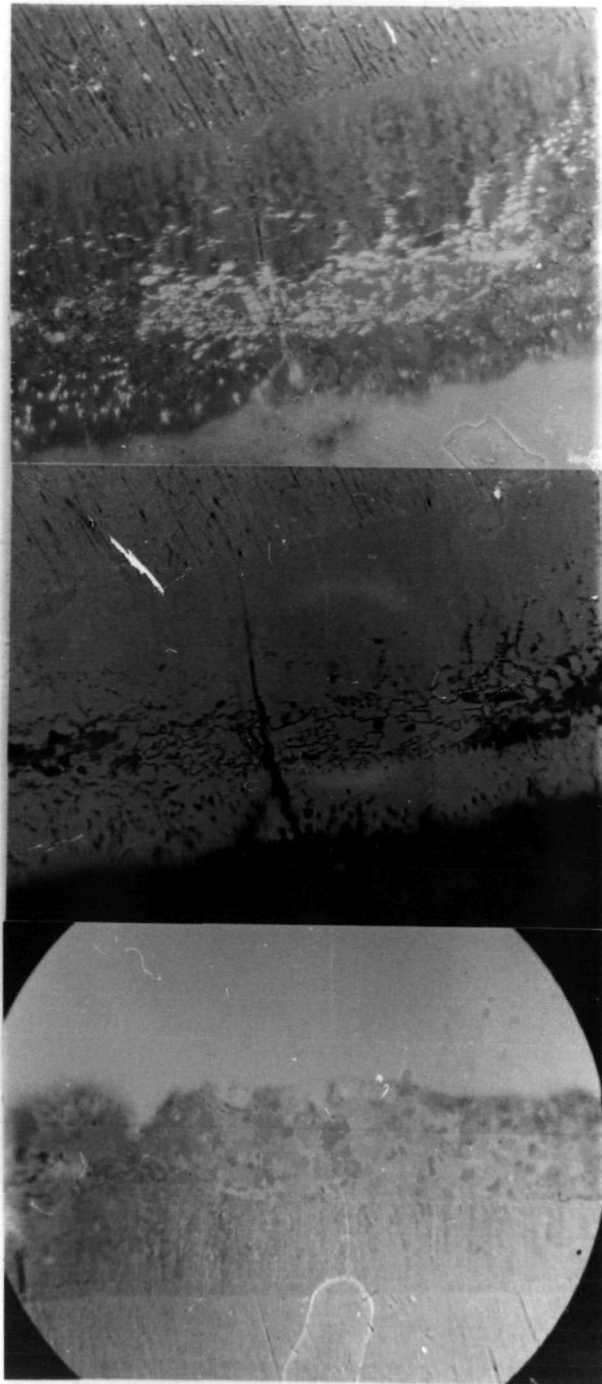
Plate 8 VH109 after furnace cycling, 5 times, in air to 2400 F. Coating has developed columnar morphology. Top & center photo show same area, bright field and polarized light respectively. 425X (bottom), 660x (center & top).

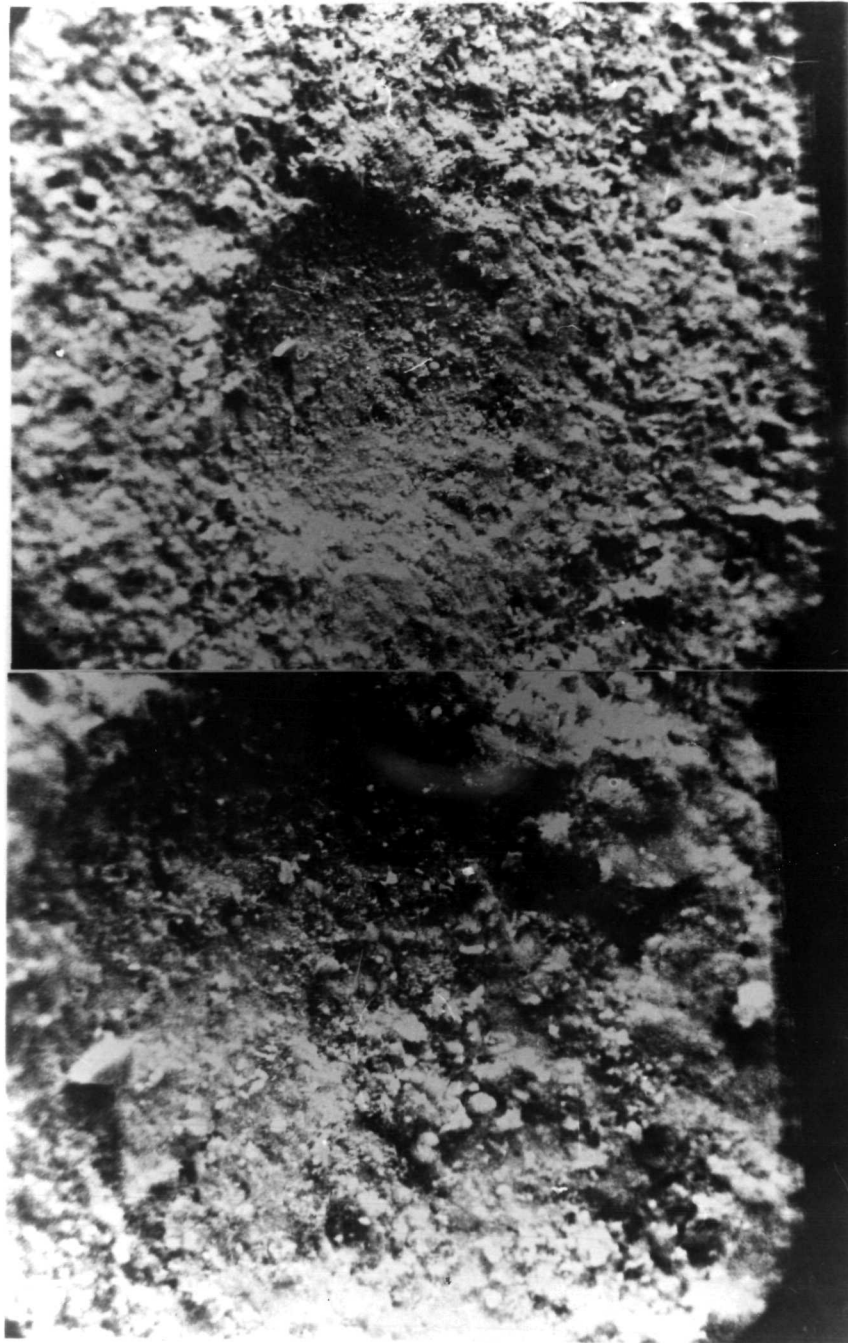
the coating to the Cb 752 substrate. It may be seen that the defect has healed and is not greatly different in appearance from the surrounding coating. Unfortunately the SEM micrographs of Plate 10 were taken with a different instrument at different settings so that no photographs are available to properly compare the coating by appearance of R512E after furnace cycling as compared with Arc-jet testing. To the unaided eye there was little difference. Optical dark field micrographs, Plate 12 suggest a greater difference than was apparent. It is thought that a detailed and careful investigation will be necessary to ascertain what the differences really are. Since Arc-jet testing is slower and more expensive such a study may be worthwhile.

Plate 10 R512E after arc-jet testing (see plate 12)
This is an SEM micrograph of a synthetic defect (a 0.01"
hole to the substrate) after testing. Upper 190x, lower
440x.

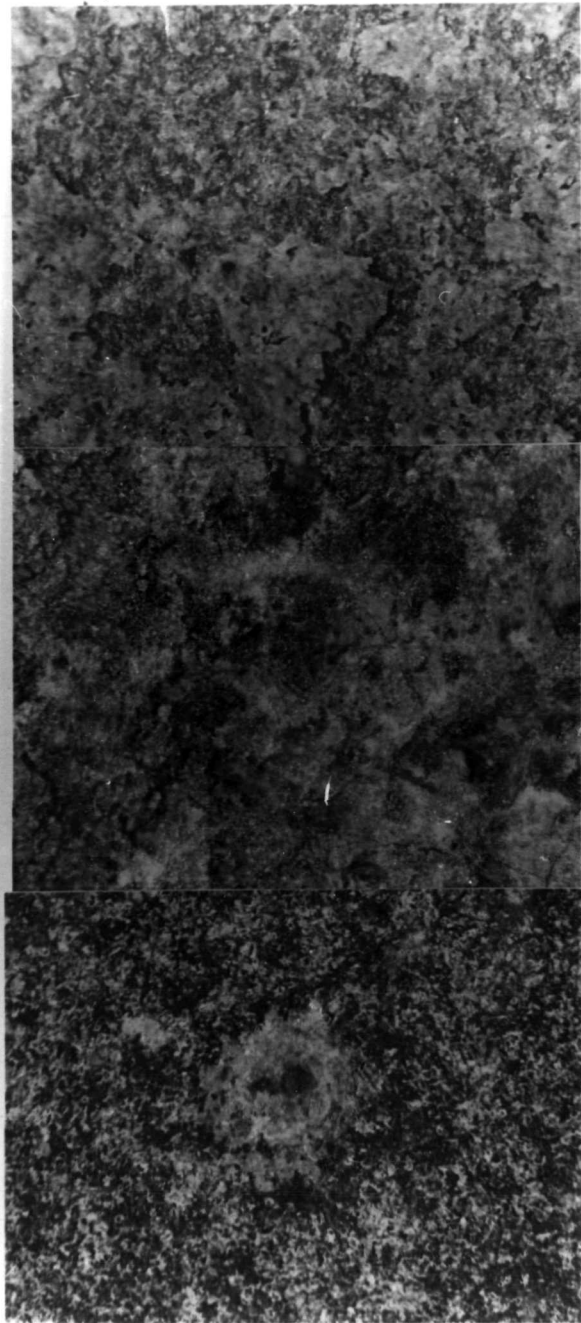
Plate 12 Optical dark field micrographs. Top, 90x, R512E after furnace cycling. Center, 90x, VH109 after furnace cycling. Bottom, 75x, R512E arc-jet tested, synthtic defect in center.

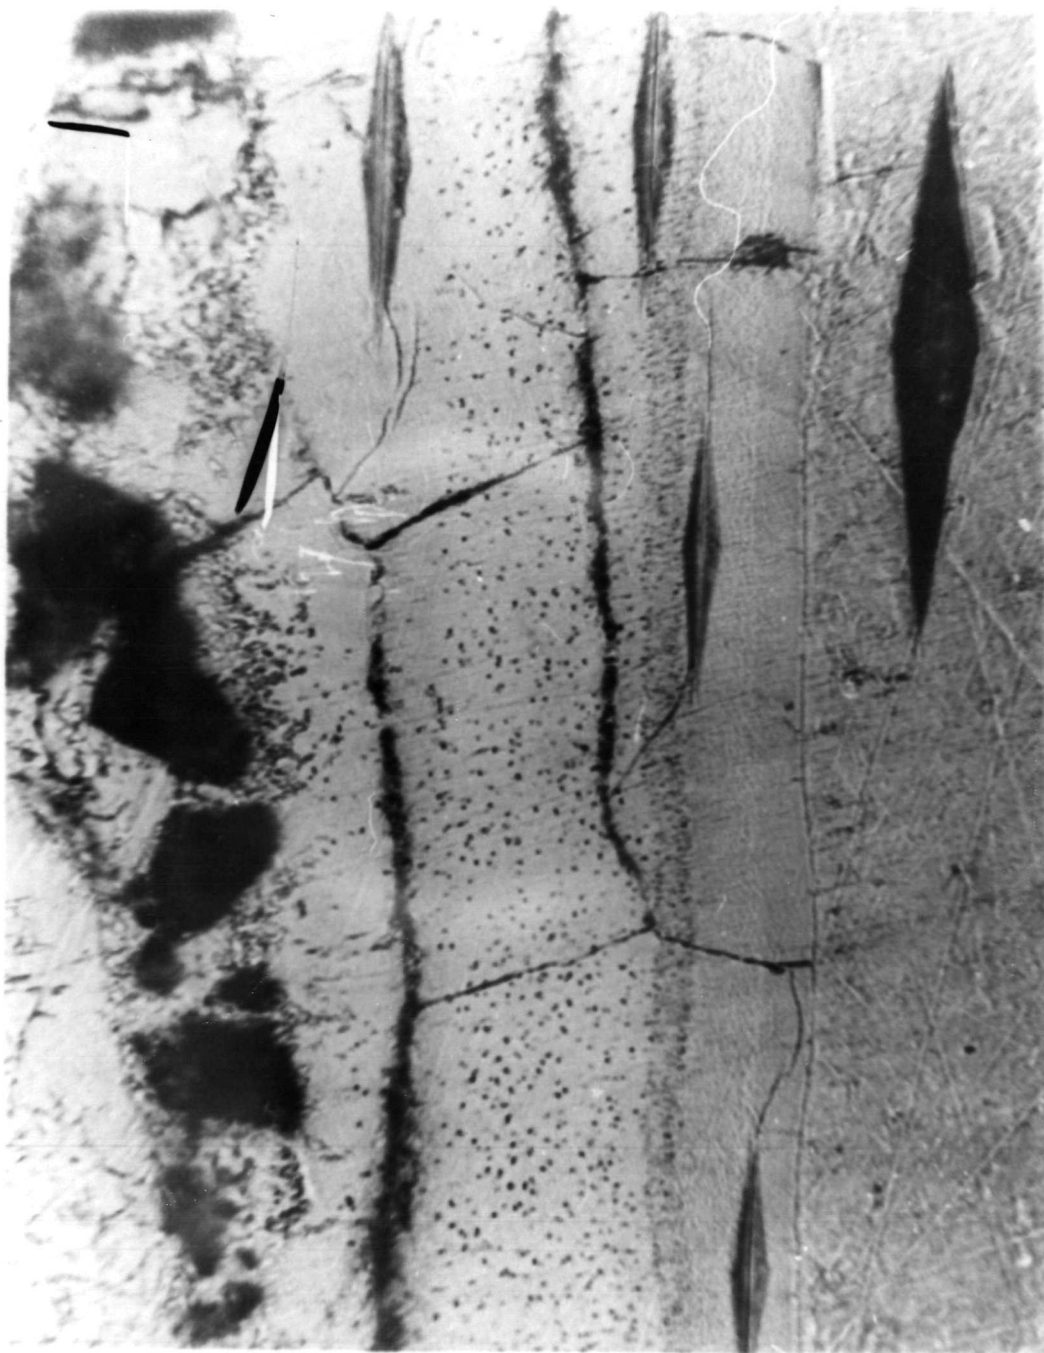
The microhardness measurements were conducted with a 200g load and revealed that the coating is extremely hard. The Knoop indenter which was used caused cracks to appear at the indentations thereby inducing hardness numbers which are probably erroneously low. The microhardness tester could not load at less than 100g and even this load caused cracking. Some data obtained is presented in Table 2.

Plate 13 Microhardenss indentations in R512E. Substrate at right. Note cracked indentations in coating. 425x (inlarged twice in reproduction)
